Case Study: Grounding of the MONCHEGORSK, Bridge Team Management, and Passage Planning.

First presented at the Marine Casualty Symposium (MarCas) 2000,
Linthicum Heights, Maryland, USA

Case Study: Grounding of the MONCHEGORSK, September 5, 1998

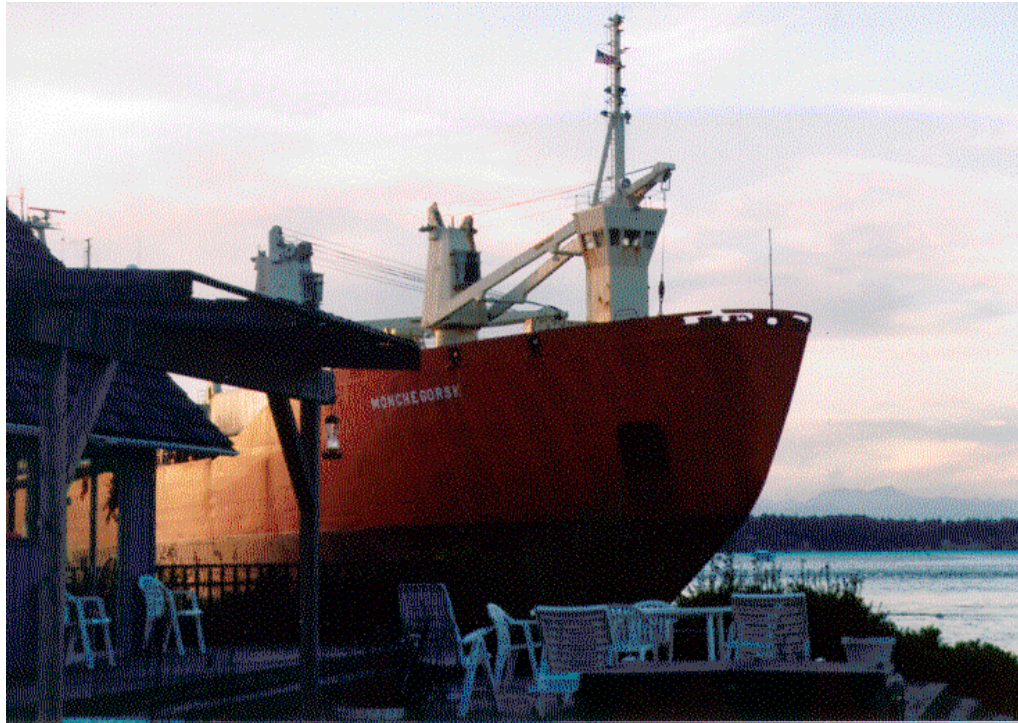
Picture of MONCHEGORSK aground at Amsterdam Bay, Anderson Island, Washington.

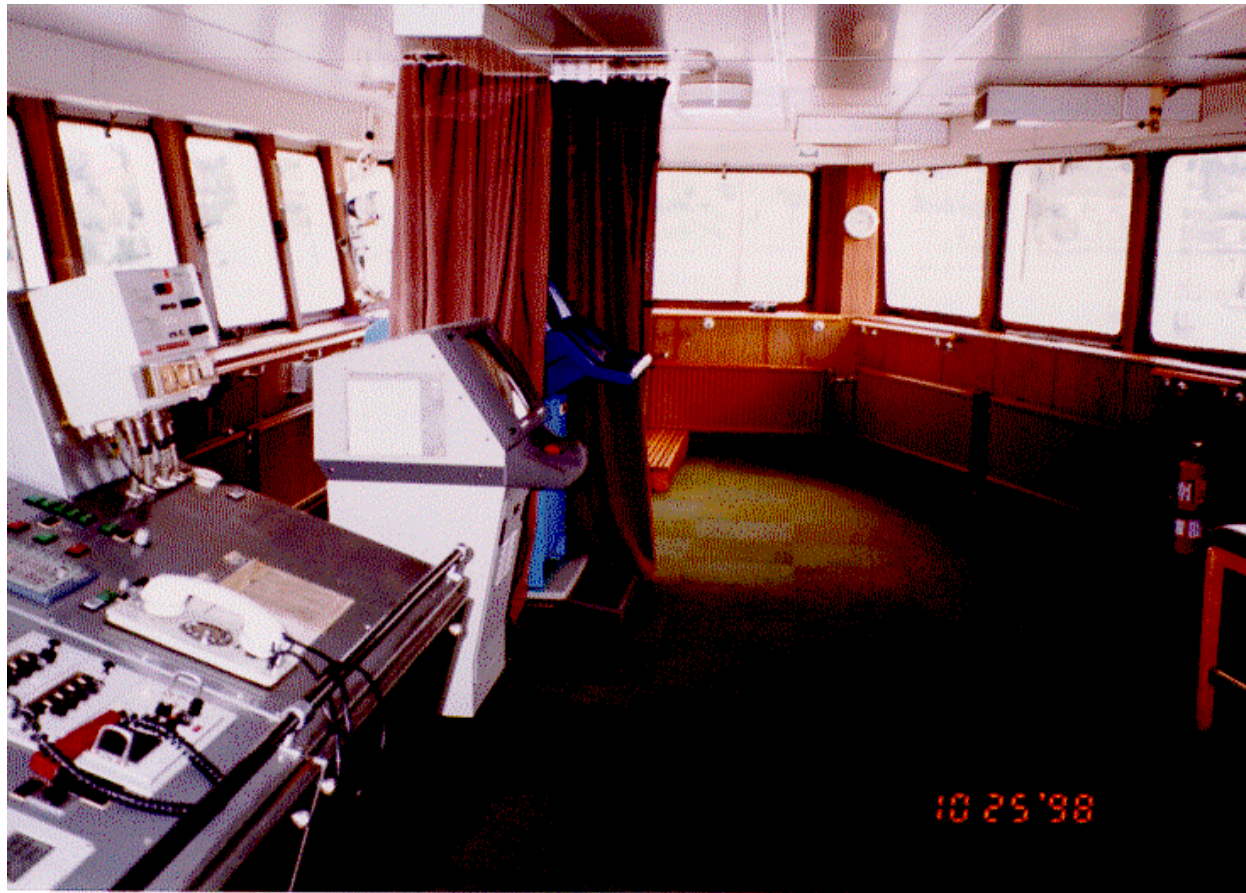
Bridge of the MONCHEGORSK looking from amidships station to starboard side. Note radar behind curtain and white phone in foreground at left. Chief Officer reported trying to use this phone to call the master before the grounding. Picture taken when MONCHEGORSK returned to Olympia, Washington about a month and a half after the grounding.

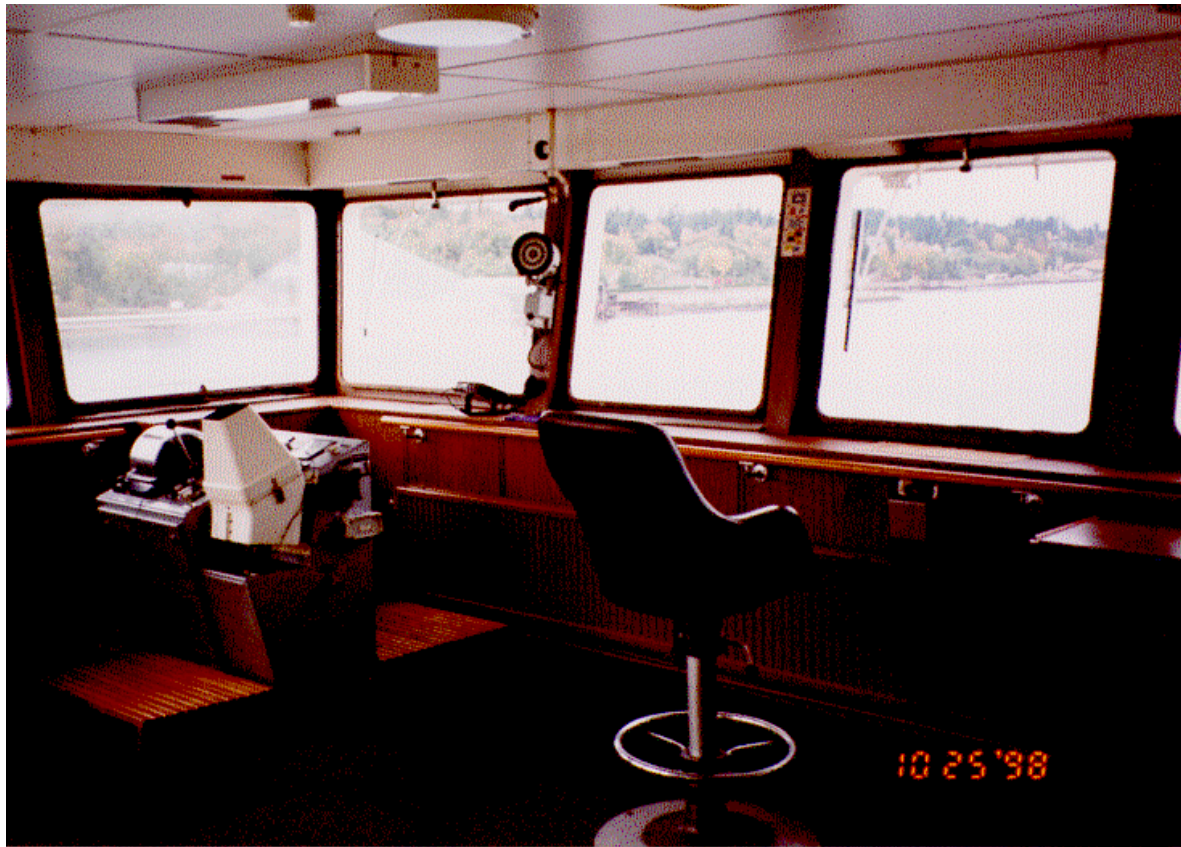
View of the port side of MONCHEGORSK's bridge taken from just left of the center control station. Note the gyro repeater mounted on stanchion between forward windows. The pilot was stationed at the port windows in the minutes preceding the grounding. Picture taken when MONCHEGORSK returned to Olympia, Washington about a month and a half after the grounding.

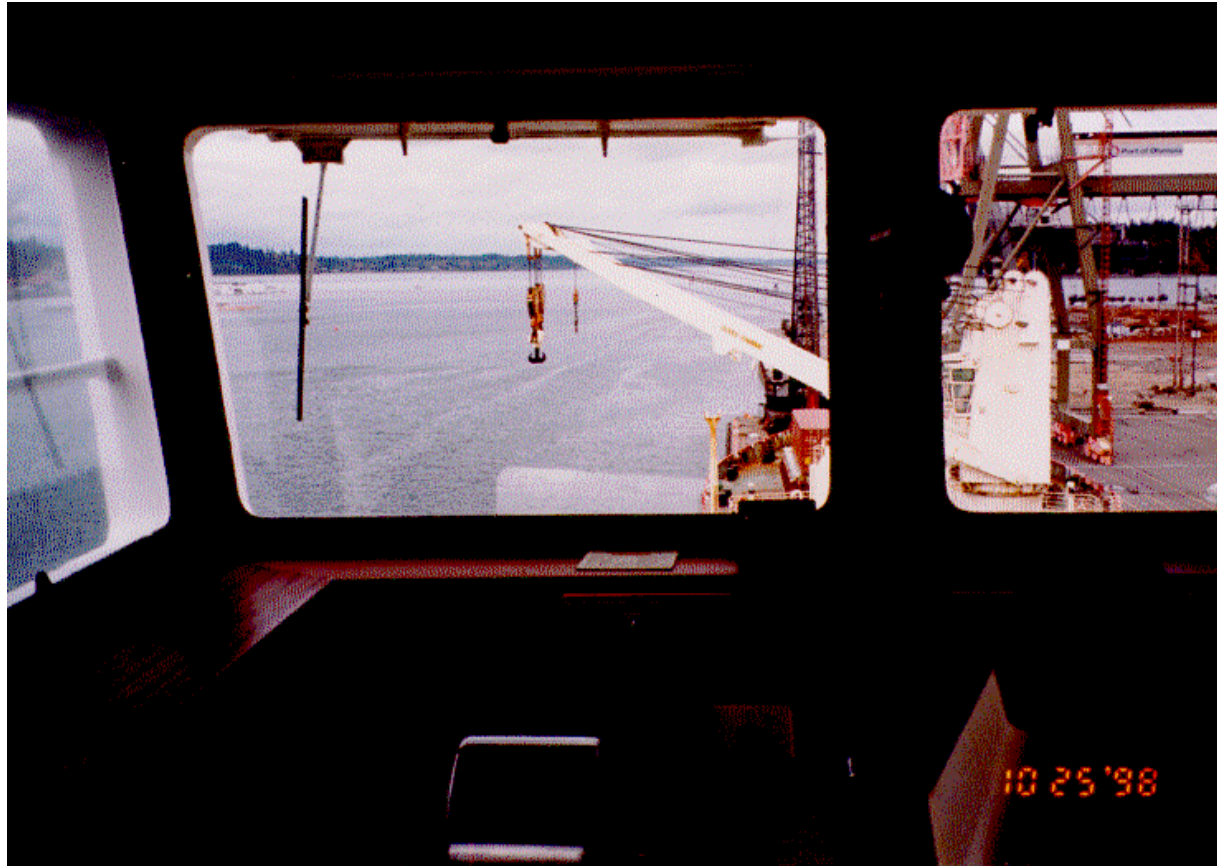
Looking forward through port bridge windows from control station. Pilot was stationed in this window in the minutes preceding the grounding. Picture taken when MONCHEGORSK returned to Olympia, Washington about a month and a half after the grounding.

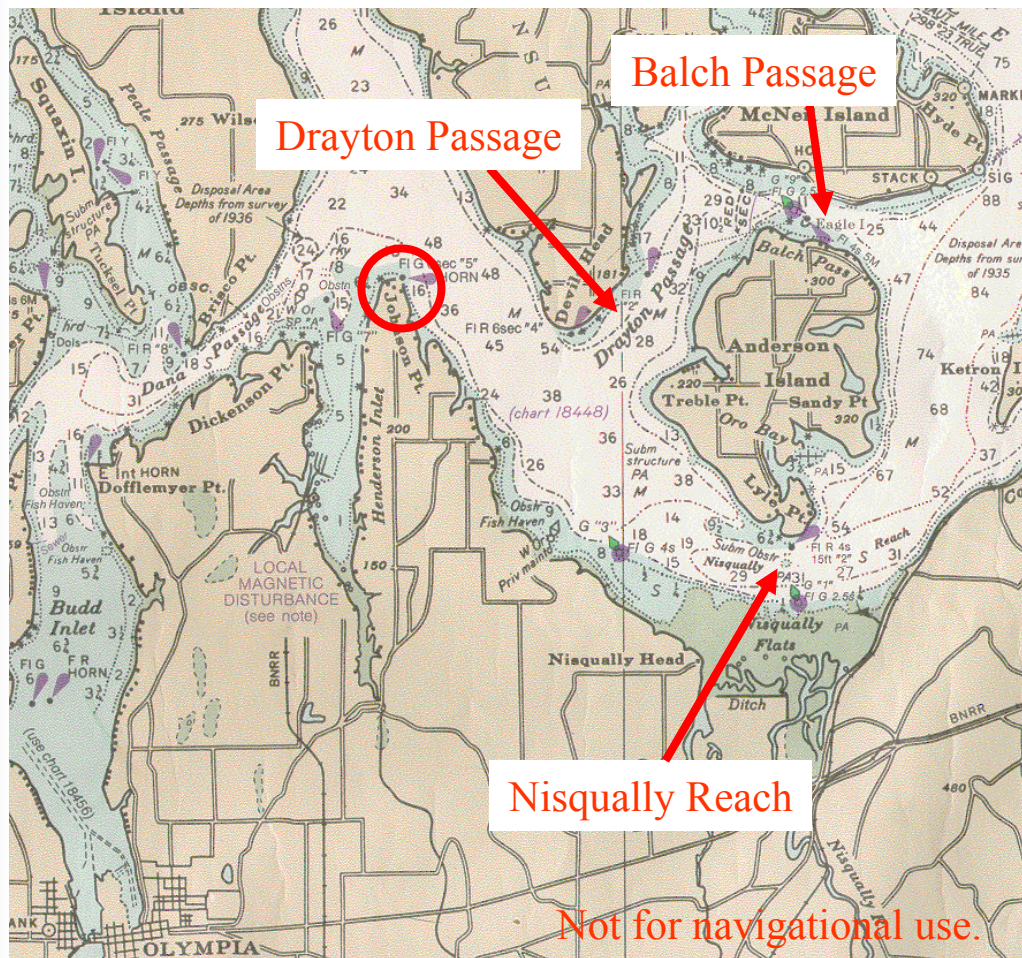
Nautical chart of the area transited outbound from Olympia, Washington (lower left) by the MONCHEGORSK prior to the grounding.

The turn at Johnson Point (circled) was useful in adjusting course recorder trace to the correct time.

Note the Nisqually Flats which is a National Wildlife Refuge. Balch Passage, between McNeil and Anderson Islands, was the path the Pilot intended to take from the start of the transit.

Nisqually Reach, south of Anderson Island, was the track the Master understood the vessel would follow.

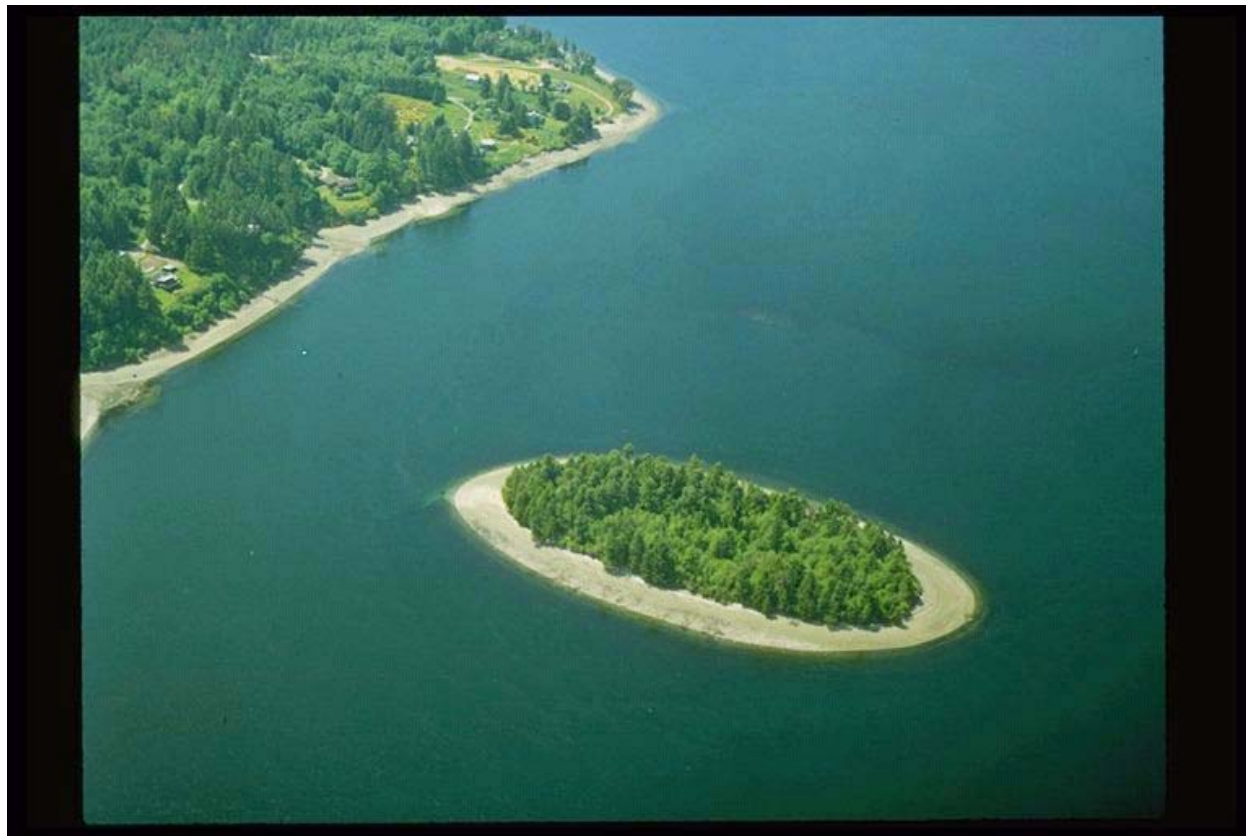
Eagle Island in Balch Passage, view looking west. The Pilot intended to transit Balch Passage, and would have passed to the right (north) of Eagle Island had the MONCHEGORSK not grounded in Drayton Passage, the northern extent of which can just be seen in the photo at upper center.

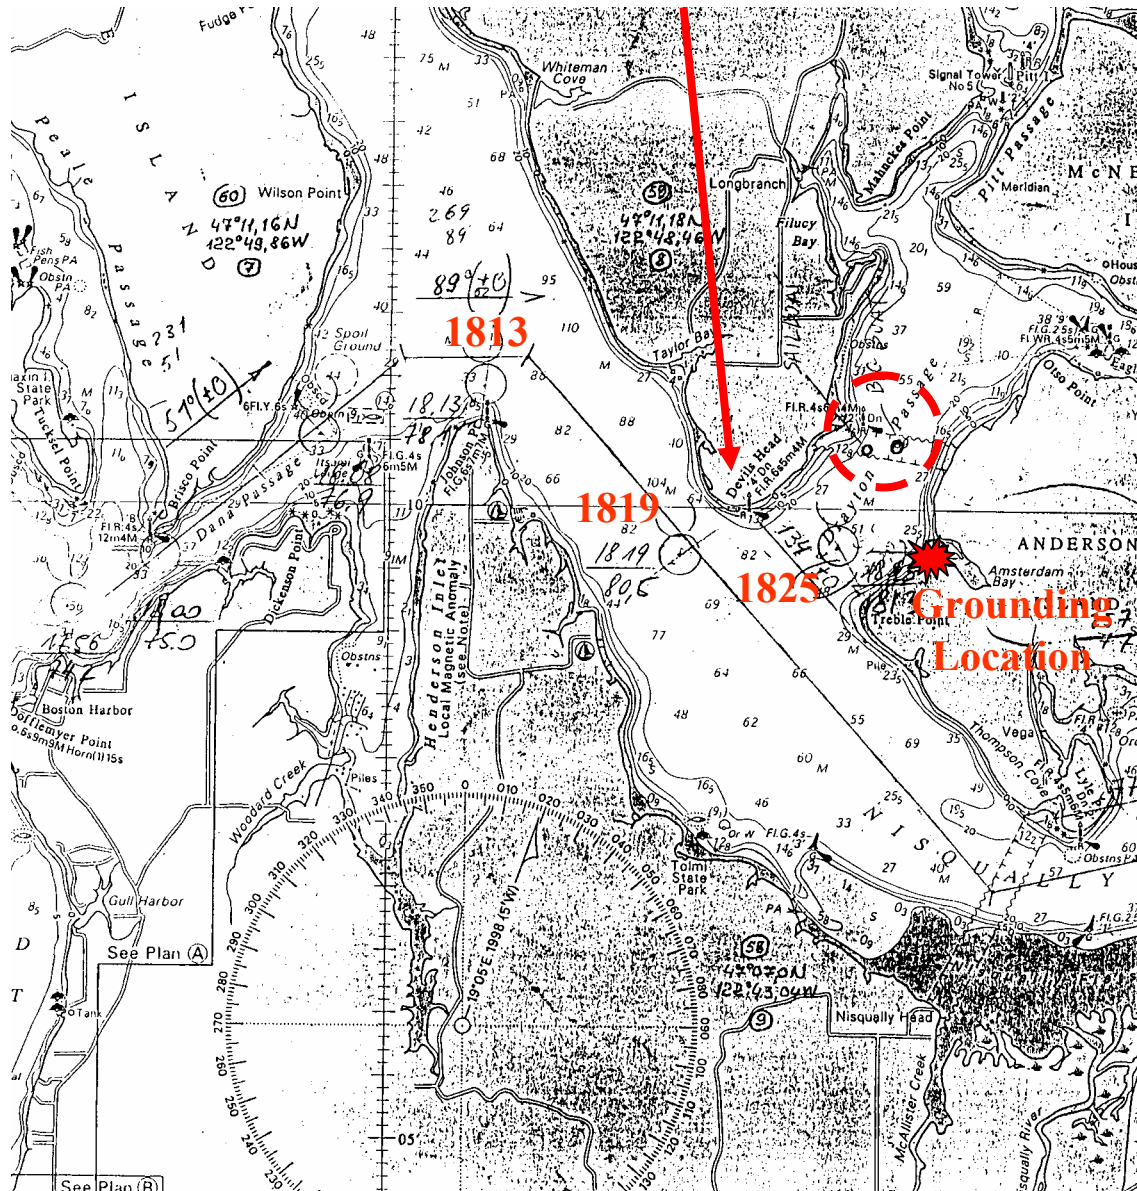
Devil's Head

Chart copy from
MONCHEGORSK
showing trackline laid
down and fixes taken
by the Chief Officer.

Note the departure
from the intended route
at Devil's Head, the
last fix in Drayton
Passage at 1825, and
the ship's eventual
grounded position on
the west side of
Anderson Island
(Amsterdam Bay).
Also noted are the
positions of small
vessels (in circle)
indicated by the Chief
Officer for the USCG.

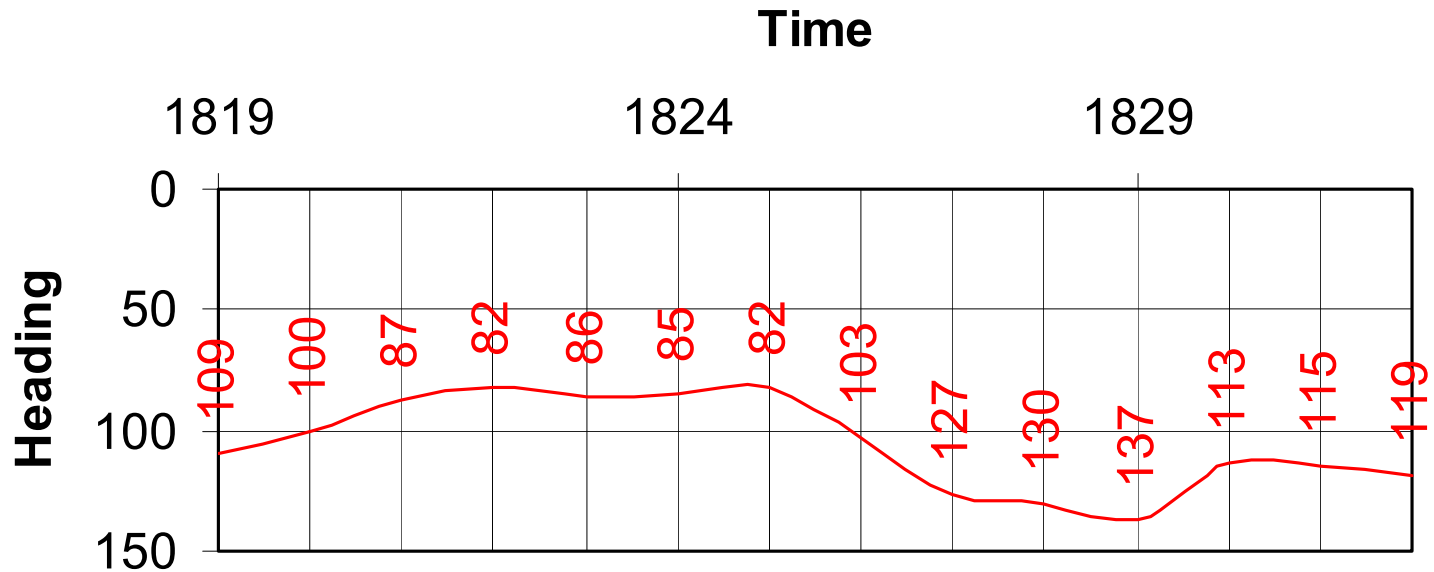
**Corrected Heading (+32 degrees)
Corrected Time (+3 minutes)**

Course recorder information had to be adjusted for both course and time because the Chief Officer did not start it before the MONCHEGORSK departed the dock. He annotated the time as 1737. Using the ship's position as recorded by the Chief Officer on the chart, an additional correction of 2 to 3 minutes was found to be necessary. A suggested 6-minute adjustment was checked but did not correlate well with other data. The 32 degree course correction was derived from the recorded heading versus the observed grounded heading.

Plot of the MONCHEGORSK's heading versus time after the ship began its turn to port around Devil's Head. Note start of turn to right at 1825, the slowing of the turn at 1827, and the maximum heading of 137 degrees at 1829. Grounding time was estimated to be 1830.

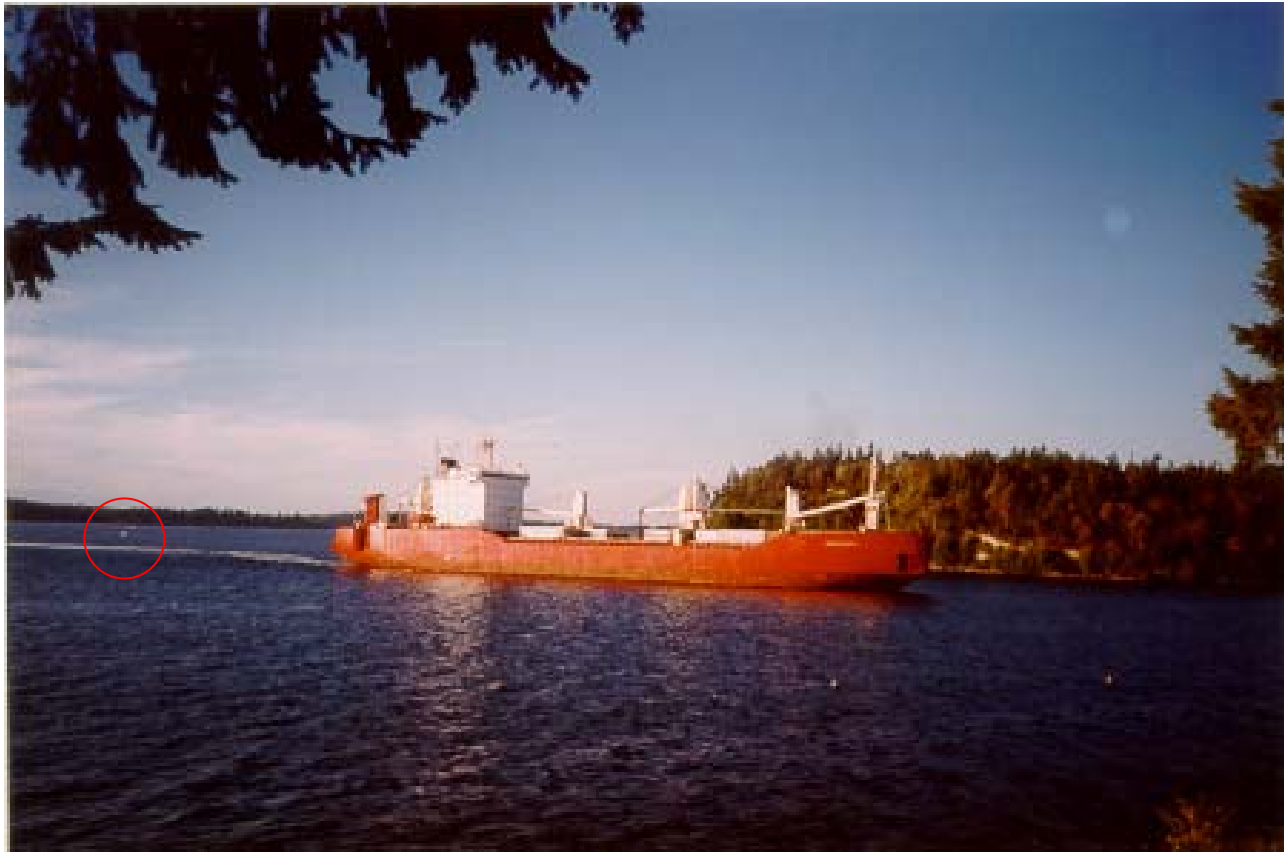
MONCHEGORSK approaching Amsterdam Bay on September 5, 1998. View is from homeowner's property south of the Bay entrance looking approximately north. Small power boat can again be discerned behind the ship (circled). Note white water in ship's wake--indicating the ship is backing at this point.

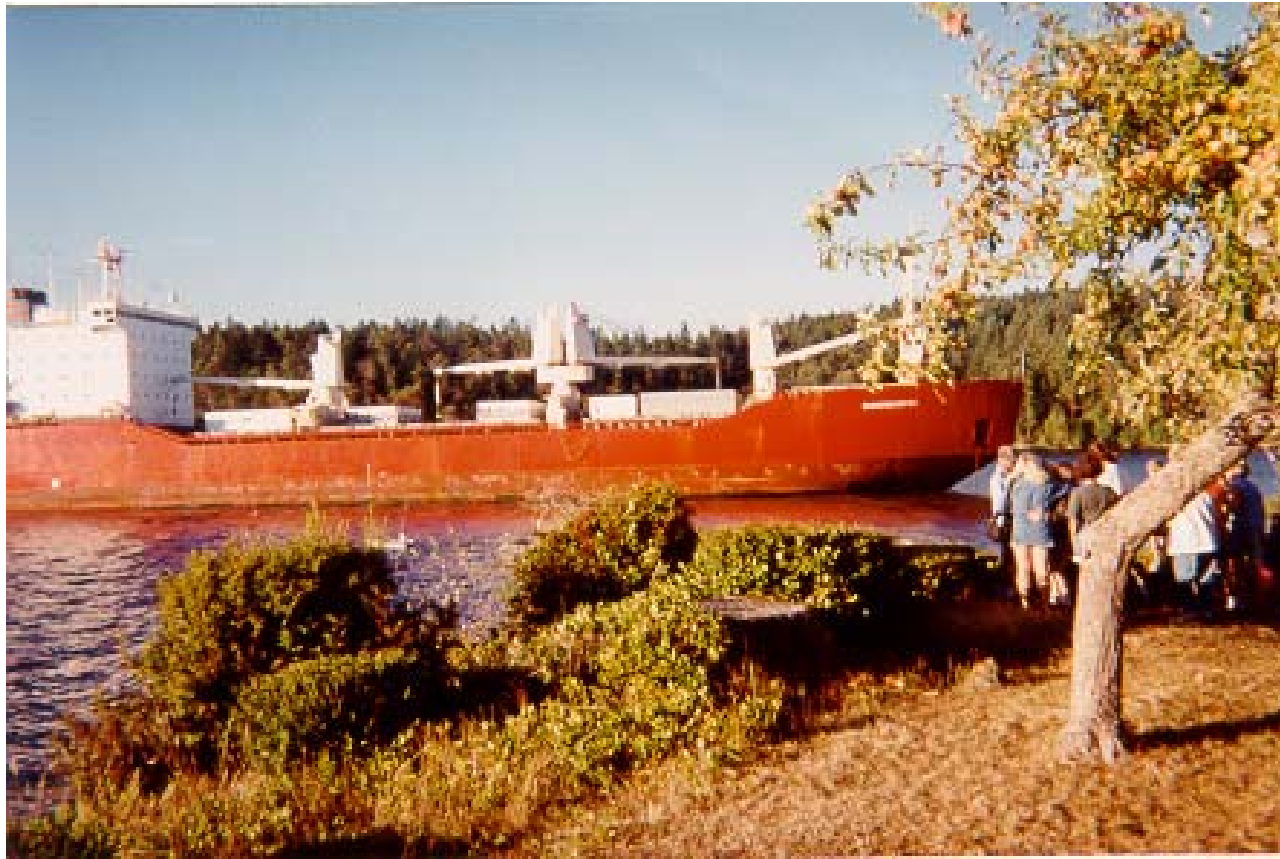
MONCHEGORSK aground in Amsterdam Bay on September 5, 1998. View is from homeowner's property south of the Bay. Starboard anchor chain can be seen leading to the water. Note small group of local residence to right in the photo.

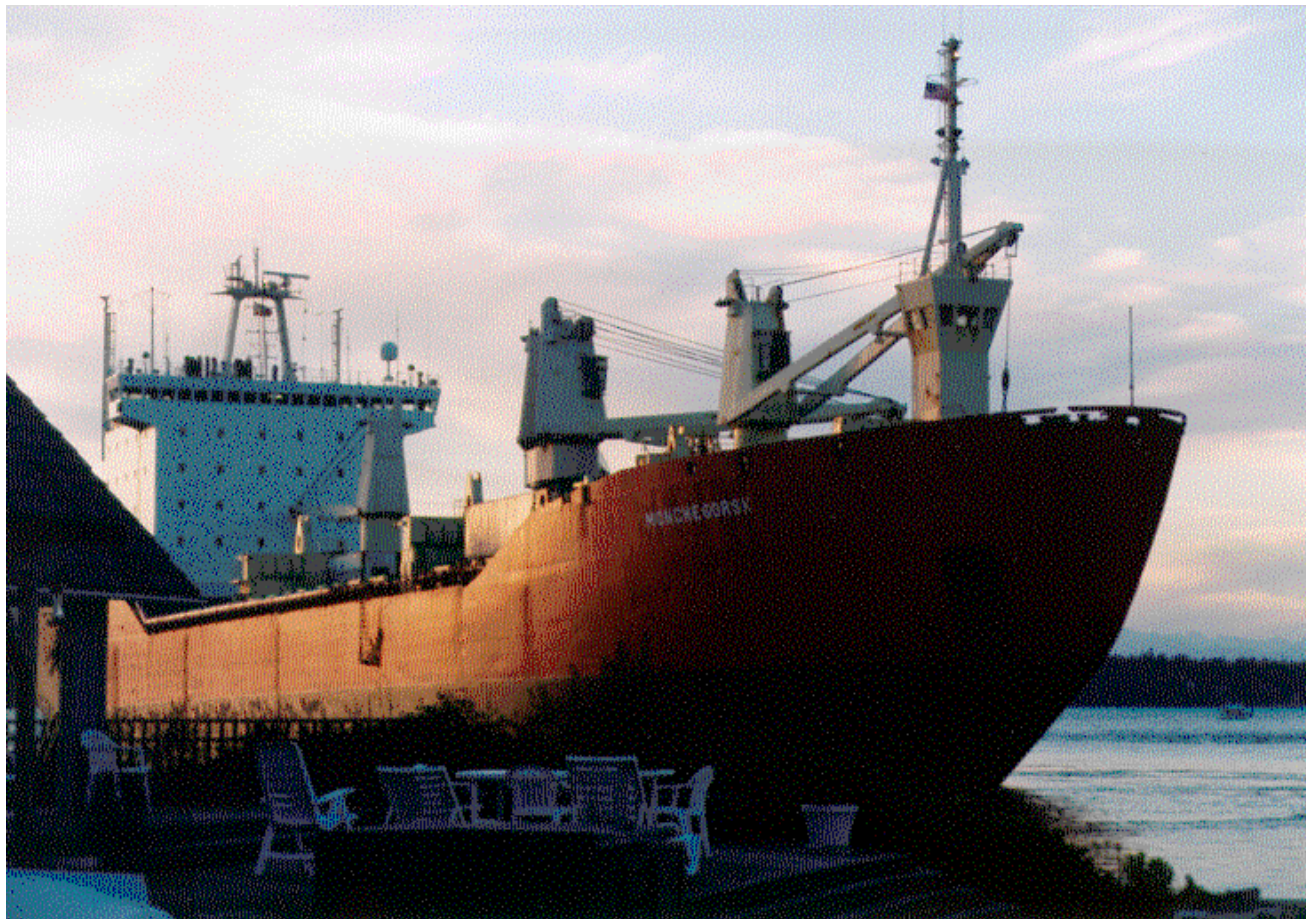
Picture of MONCHEGORSK aground at Amsterdam Bay taken later in the evening. At this time the tug SEA CLOUD is made up to the stern of the MONCHEGORSK by a tow wire and is pulling.
